Manhole Inspection Summary

Manhole # S1500_024MH

Insp Date: **7/22/09 2:29 PM**

Location Address: **2607 GWYNNS FALLS PKWY**

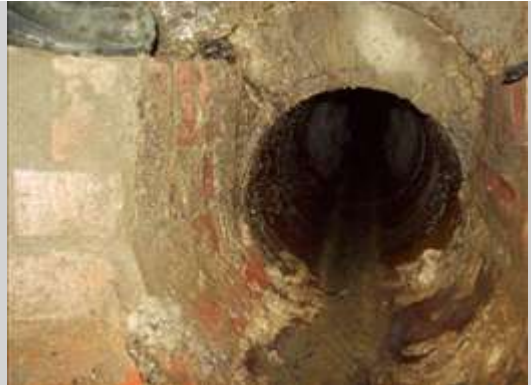
12 O'Clock Outflow

12 in. Circular Gravity Sewer
Pipe Out @ 12 O'Clock

Pipe Height: (in.) Direct
Pipe Material: **Clay** ☐ Pipe Lined
Invert Depth: **6.94** (ft.) Flow Characteristics: **Slow**
Deposits: ☒ None ☐ Mud ☐ Sludge ☐ Debris ☐ Grease
Silt Depth: (in.) Deposits Extent:
Infiltration: **None** Pipe Seal Cond: **Sound**

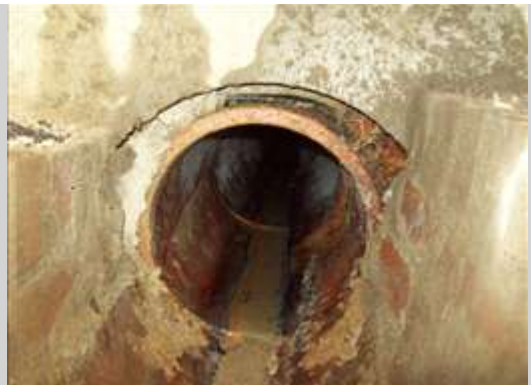
6 O'Clock Inflow

12 in. Circular Gravity Sewer
Pipe In @ 6 O'Clock

Pipe Height: (in.) Direct
Pipe Material: **Clay** ☐ Pipe Lined
Invert Depth: **6.96** (ft.) Flow Characteristics: **Slow**
Deposits: ☒ None ☐ Mud ☐ Sludge ☐ Debris ☐ Grease
Silt Depth: (in.) Deposits Extent:
Infiltration: **None** Pipe Seal Cond: **Sound**

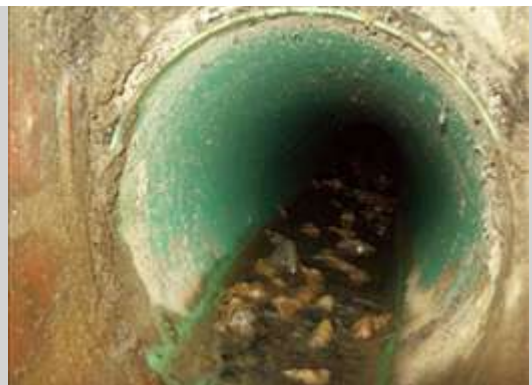
9 O'Clock Inflow

8 in. Circular Gravity Sewer
Pipe In @ 9 O'Clock

Infiltration: **None**

Pipe Seal Cond: **Sound**
